Memo

Subject: Report to Advocates for the Tongariro River on 2019/20 Works

Flood Scheme Asset maintenance 2019/20

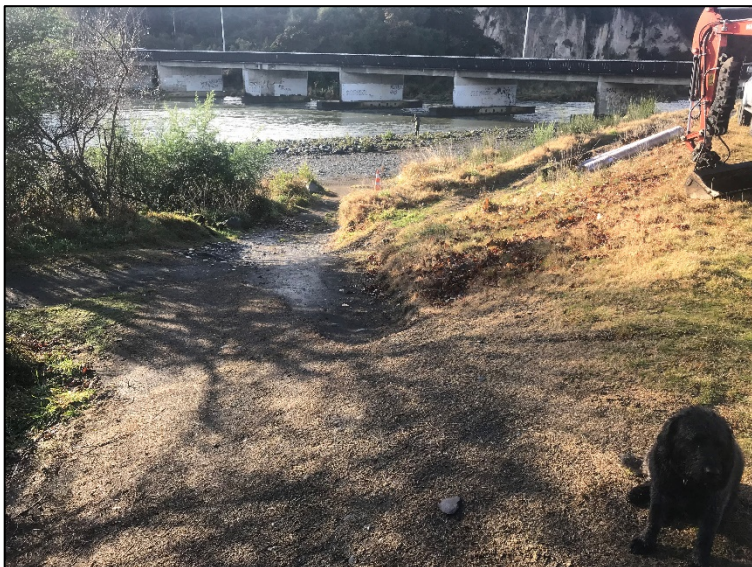
Figure 1: Bridge Lodge Stop Bank Maintenance.

Defect: Vehicle damage compromising stability.

Maintenance: Access blocked and face re-shaped, coconut matted and re seeded.

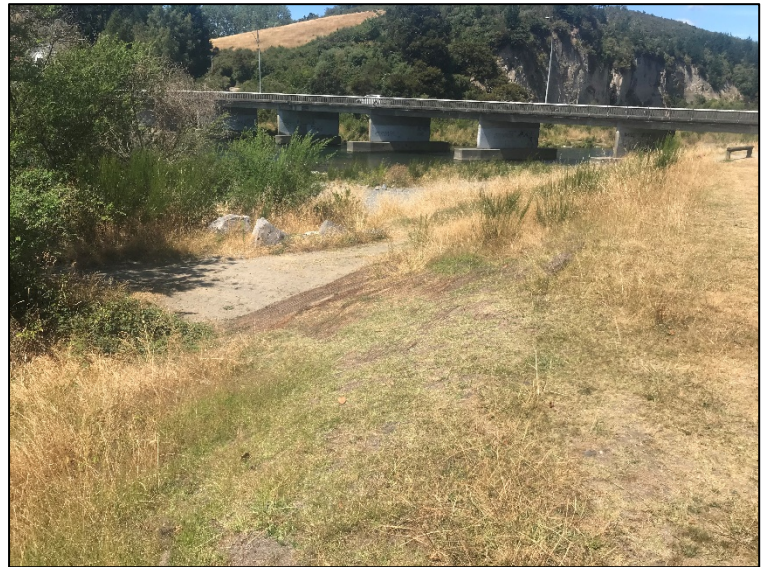
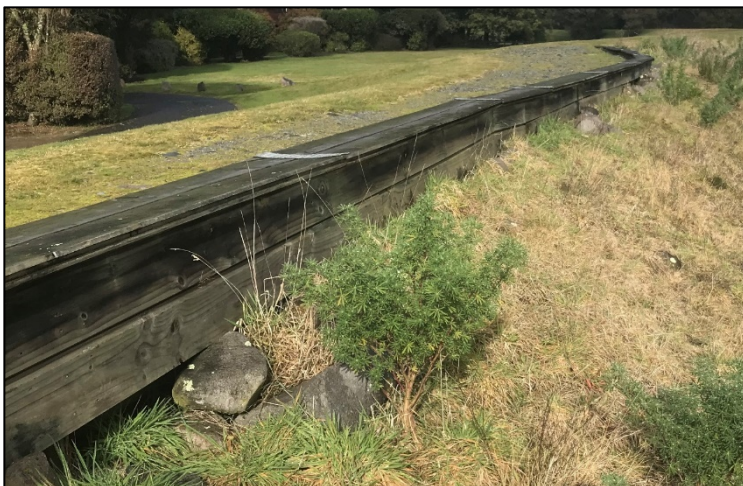
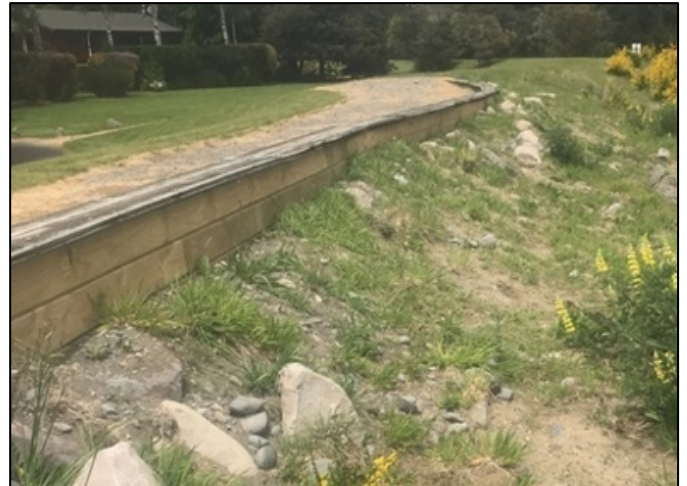
Figure 2: Tongariro Lodge Floodwall Maintenance.

Defect: Warped / damaged sections.

Maintenance: Warped and damaged sections replaced with the river side batter reshaped compacted and seeded.

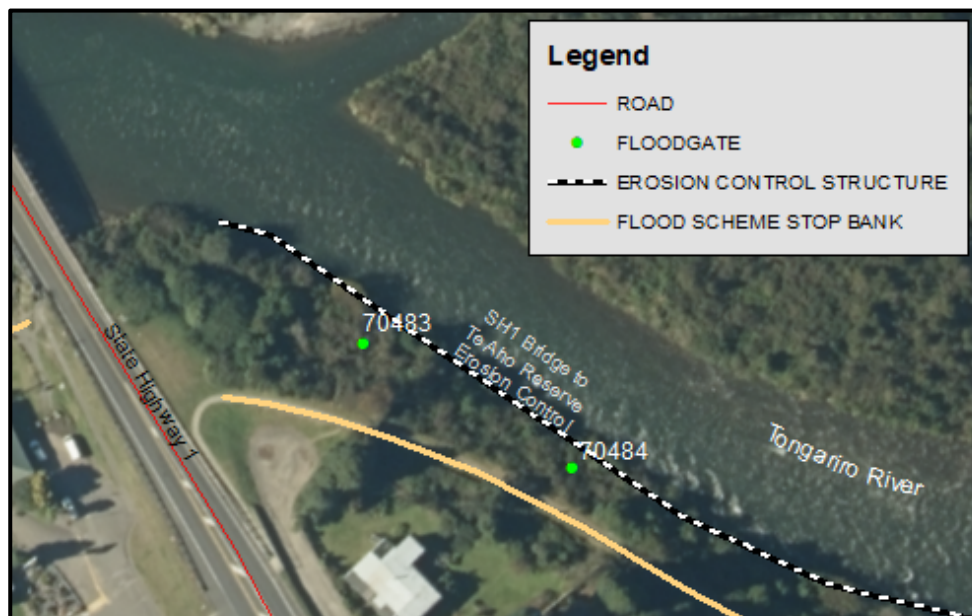
Figure 4: Te Aho Rd Flood gate flap valve locations.

The Culvert 1 & 2 Floodgates are situated on the SH1 Bridge to Te Aho Reserve Erosion Control Rock Wall on the Tongariro River, Turangi. The flap valves of these two floodgates are currently assessed as unserviceable due to pest vegetation growing along this section of the rock wall preventing access to inspect or maintain them. The vegetation consists primarily of blackberry and broom.

My recommendation is to remove all vegetation within the rock wall allowing access to inspect. The vegetation removed will also allow for easier maintenance of the rockwall if required.

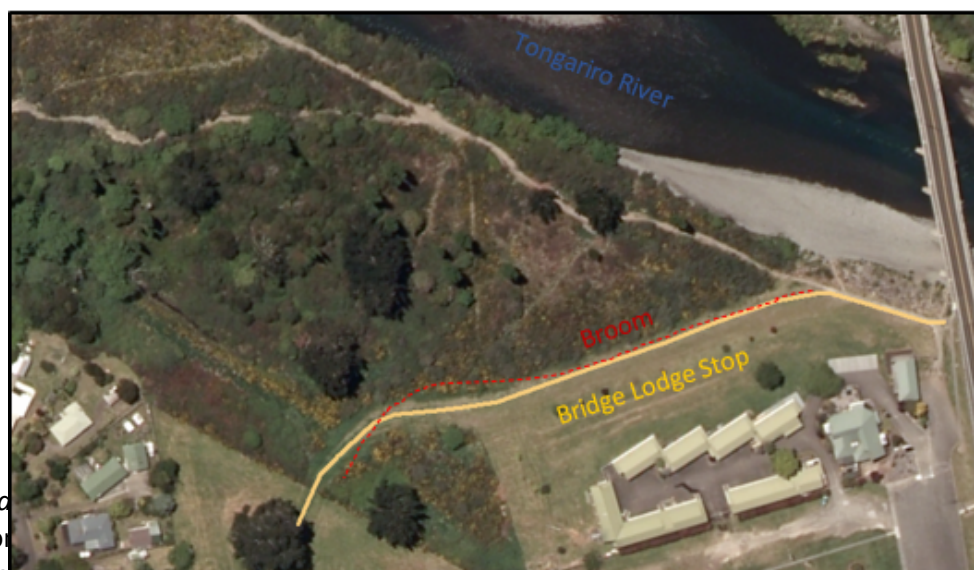
Figure 5: Bridge lodge Stop Bank Location

Pest broom on the river side of the Bridge Lodge Stop Bank needs to be sprayed in order to keep the stop bank clear of vegetation. This prevents woody vegetation growth from damaging the stop bank and allows for greater ease when inspecting or maintaining the asset.

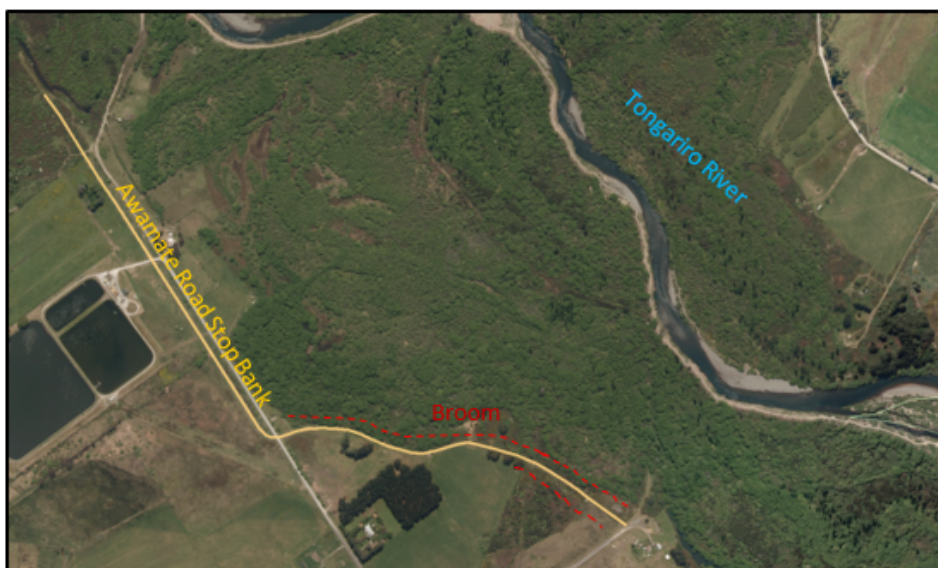
Figure 6: Awamate Rd Stop Bank Location.

Pest broom on the river side of the stop bank and the amount of broom present, mowing would be the most effective method.

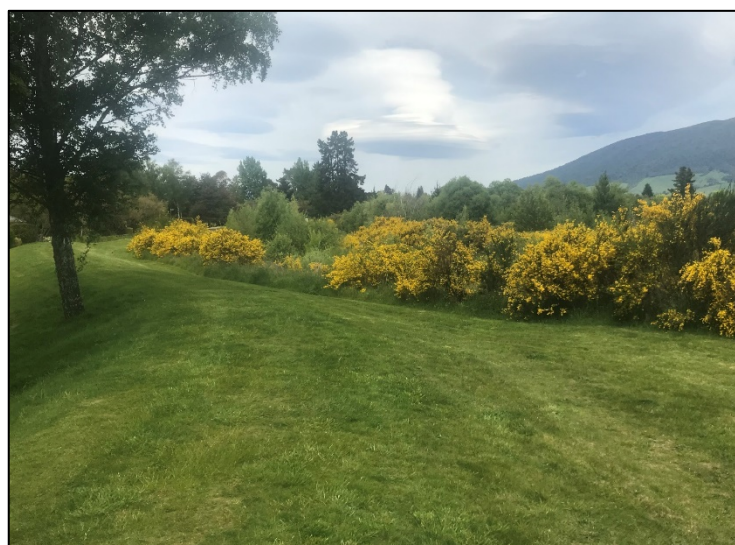
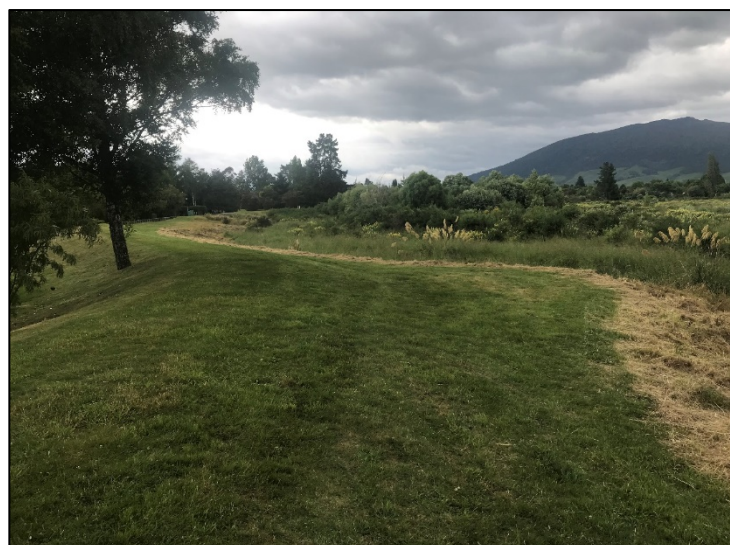
Figure 7: Before /after. Foreground - Vegetation removed from the floodplain adjacent Tongariro Lodge. Background – Invasive vegetation sprayed.

A programme to manage inappropriate invasive vegetation within the floodway also started. Unfortunately, Covid-19 lockdown reduced the planned works timeframe before winter leaf fall, however several key areas within the schemes reach have been managed. This was done by a team of three spot sprayers targeting Willow, Broom, Buddleia, Poplar and Pine on gravel shoals and islands. Areas highlighted below are expected to not flush back in leaf next summer. vegetation management is planned for the start of the 2020/2021 works season to continue this work throughout the scheme.
