## Lower Tongariro River

### Potential breakout management options study

Prepared for  
Waikato Regional Council

Prepared by  
Tonkin & Taylor Ltd

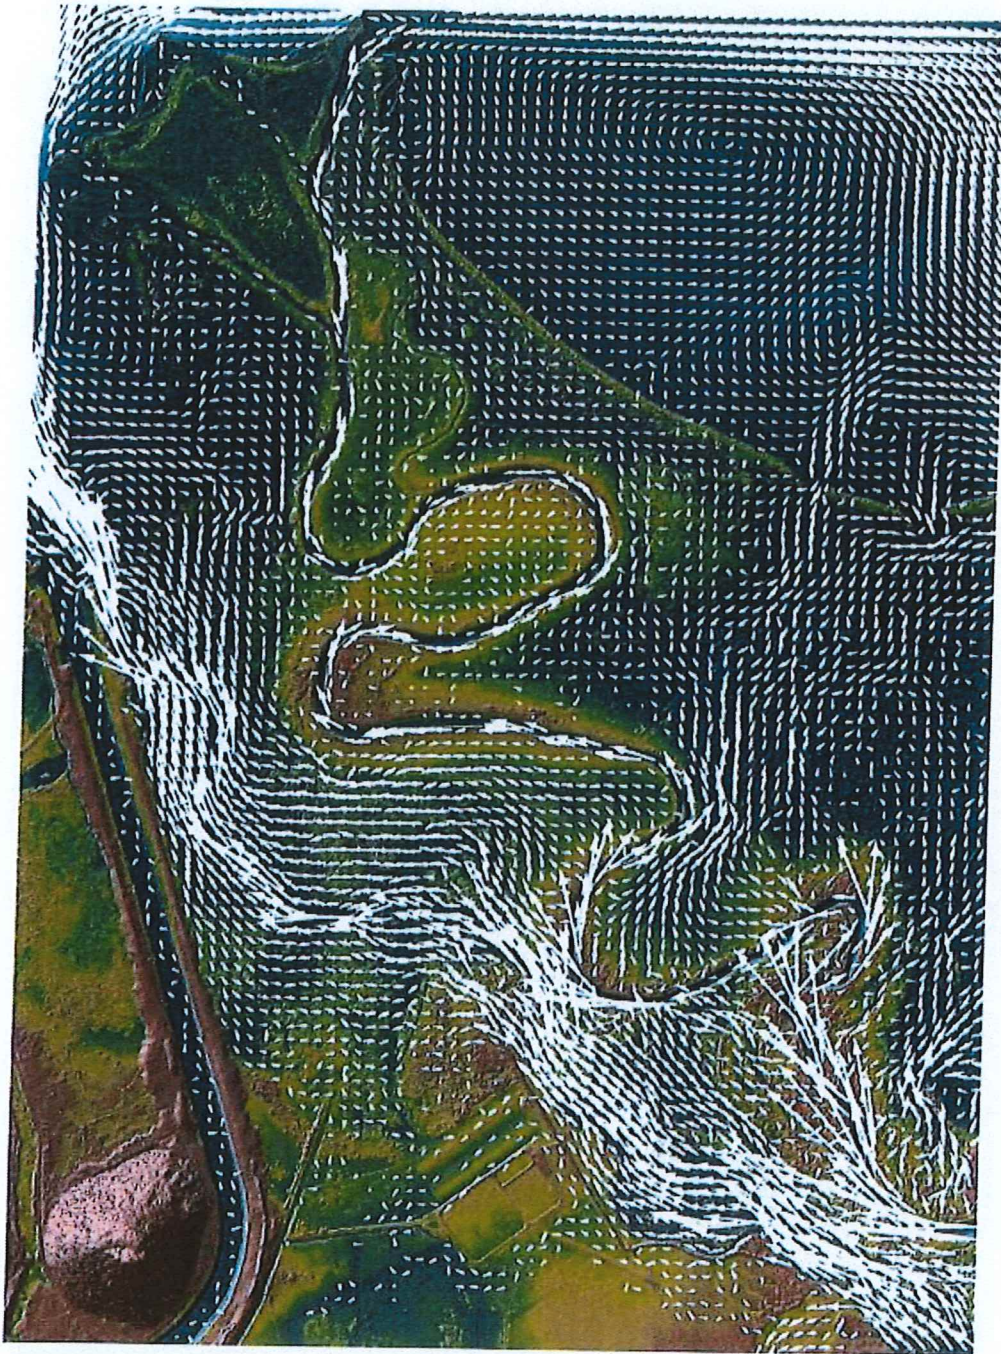
Figure 2-1 Extracted figure 4 from G Smart paper "Pre-empting flood avulsion and 2D modelling", 2011

Figure 4 Flow vectors for a 1300 cumec (50 year) flood

<p>G Smart Technical Paper ‘Pre-empting flood avulsion and 2D modelling’, 2011 Tsinghua University Press, Beijing.</p>	<p>In this paper, Mr Smart has used a 2D hydrodynamic computer model (Hydro2de) to analyse flood flows, overland flow paths, and bed shear stress. The model has been used to demonstrate where the most likely breakout (avulsion) is likely to occur, and has modelled a number of intervention strategies to see how effective they may be in preventing breakout. Figure 4 of the paper (included below) shows flow vectors in a 1300 m<sup>3</sup>/s flood flow. These clearly show the dominant overflow path is out the left bank of the river to Deep Creek with a smaller overflow path to the north from either side of Downs Pool. Note that this modelling was completed in 2011 based on aerial LIDAR survey data. The river channel in this reach has changed considerably since 2010 as described in Section 3 below.</p>

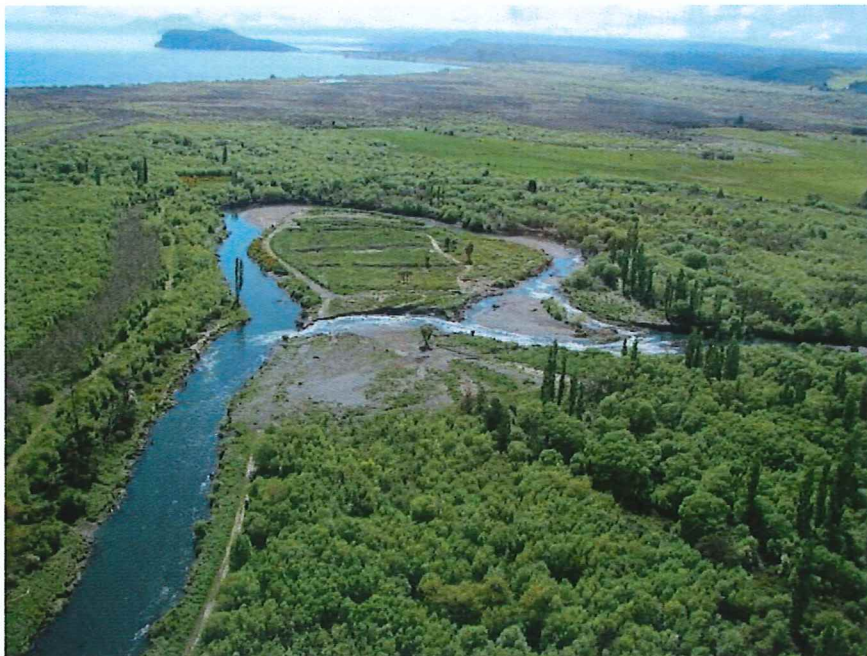
*Figure 3-1: De Latours Pool Breakout*

In 2013, during two flood events, a breakout occurred in the channel bypassing De Latours Pool, this is shown in Figure 3-1 below.

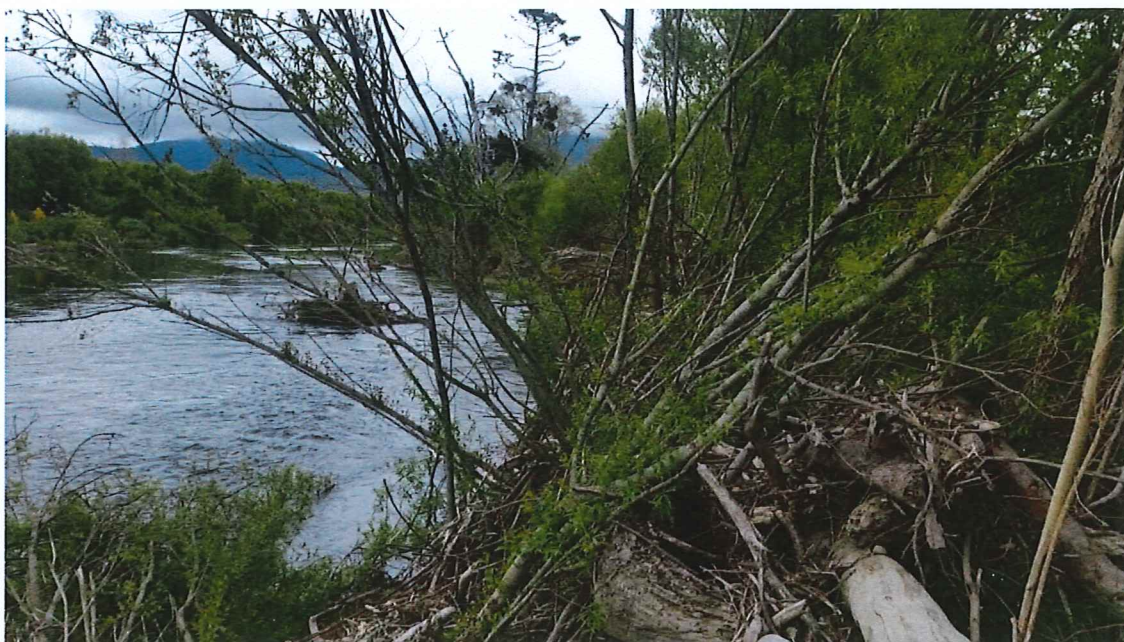
*Figure 3-3 Active erosion and overtopping of right bank immediately downstream of De Latours shortcut*

During a site visit on 28 October 2015, it was clearly evident that there is recent active erosion and overtopping of the river banks downstream of the De Latours shortcut, and this erosion is resulting in lower banks in places, thus increasing the frequency and volume of overtopping during freshes and floods. This is likely exacerbated due to less overflow from the right bank upstream of the shortcut due to bed degradation in this area. Refer to Figures 3-3 and 3-4 below.

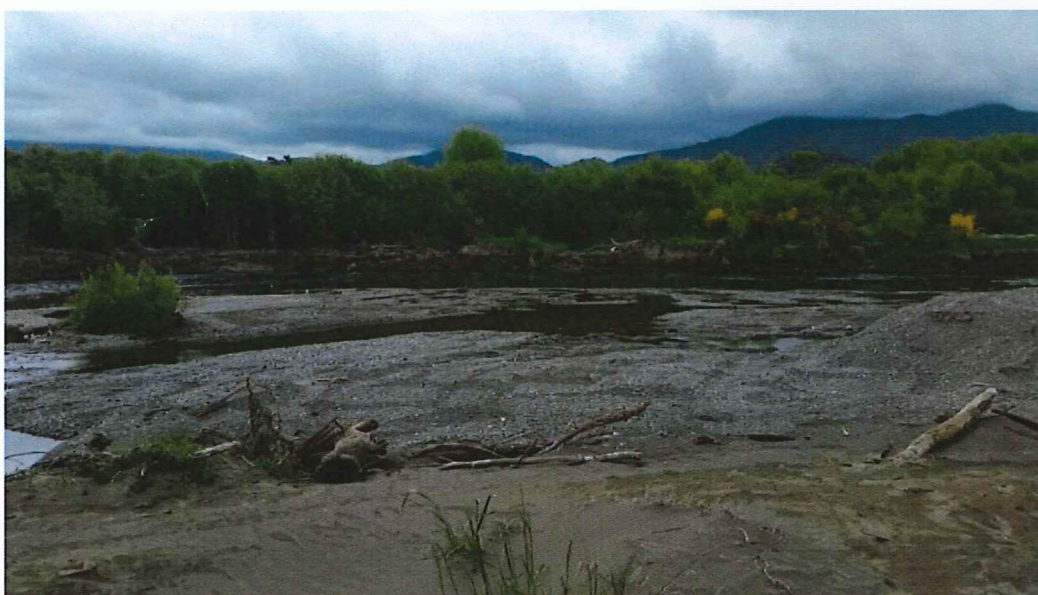
*Figure 3-4 Active erosion and overtopping of left bank at Downs Pool and sediment deposition on inside of bend. Note low areas of bank.*

The overflow from the left bank at Downs Pool flows overland to the west and enters Deep Creek. The increased volume and frequency of overtopping events is resulting in head-ward erosion of the upper reaches of deep creek (refer Figure 3-5 below).

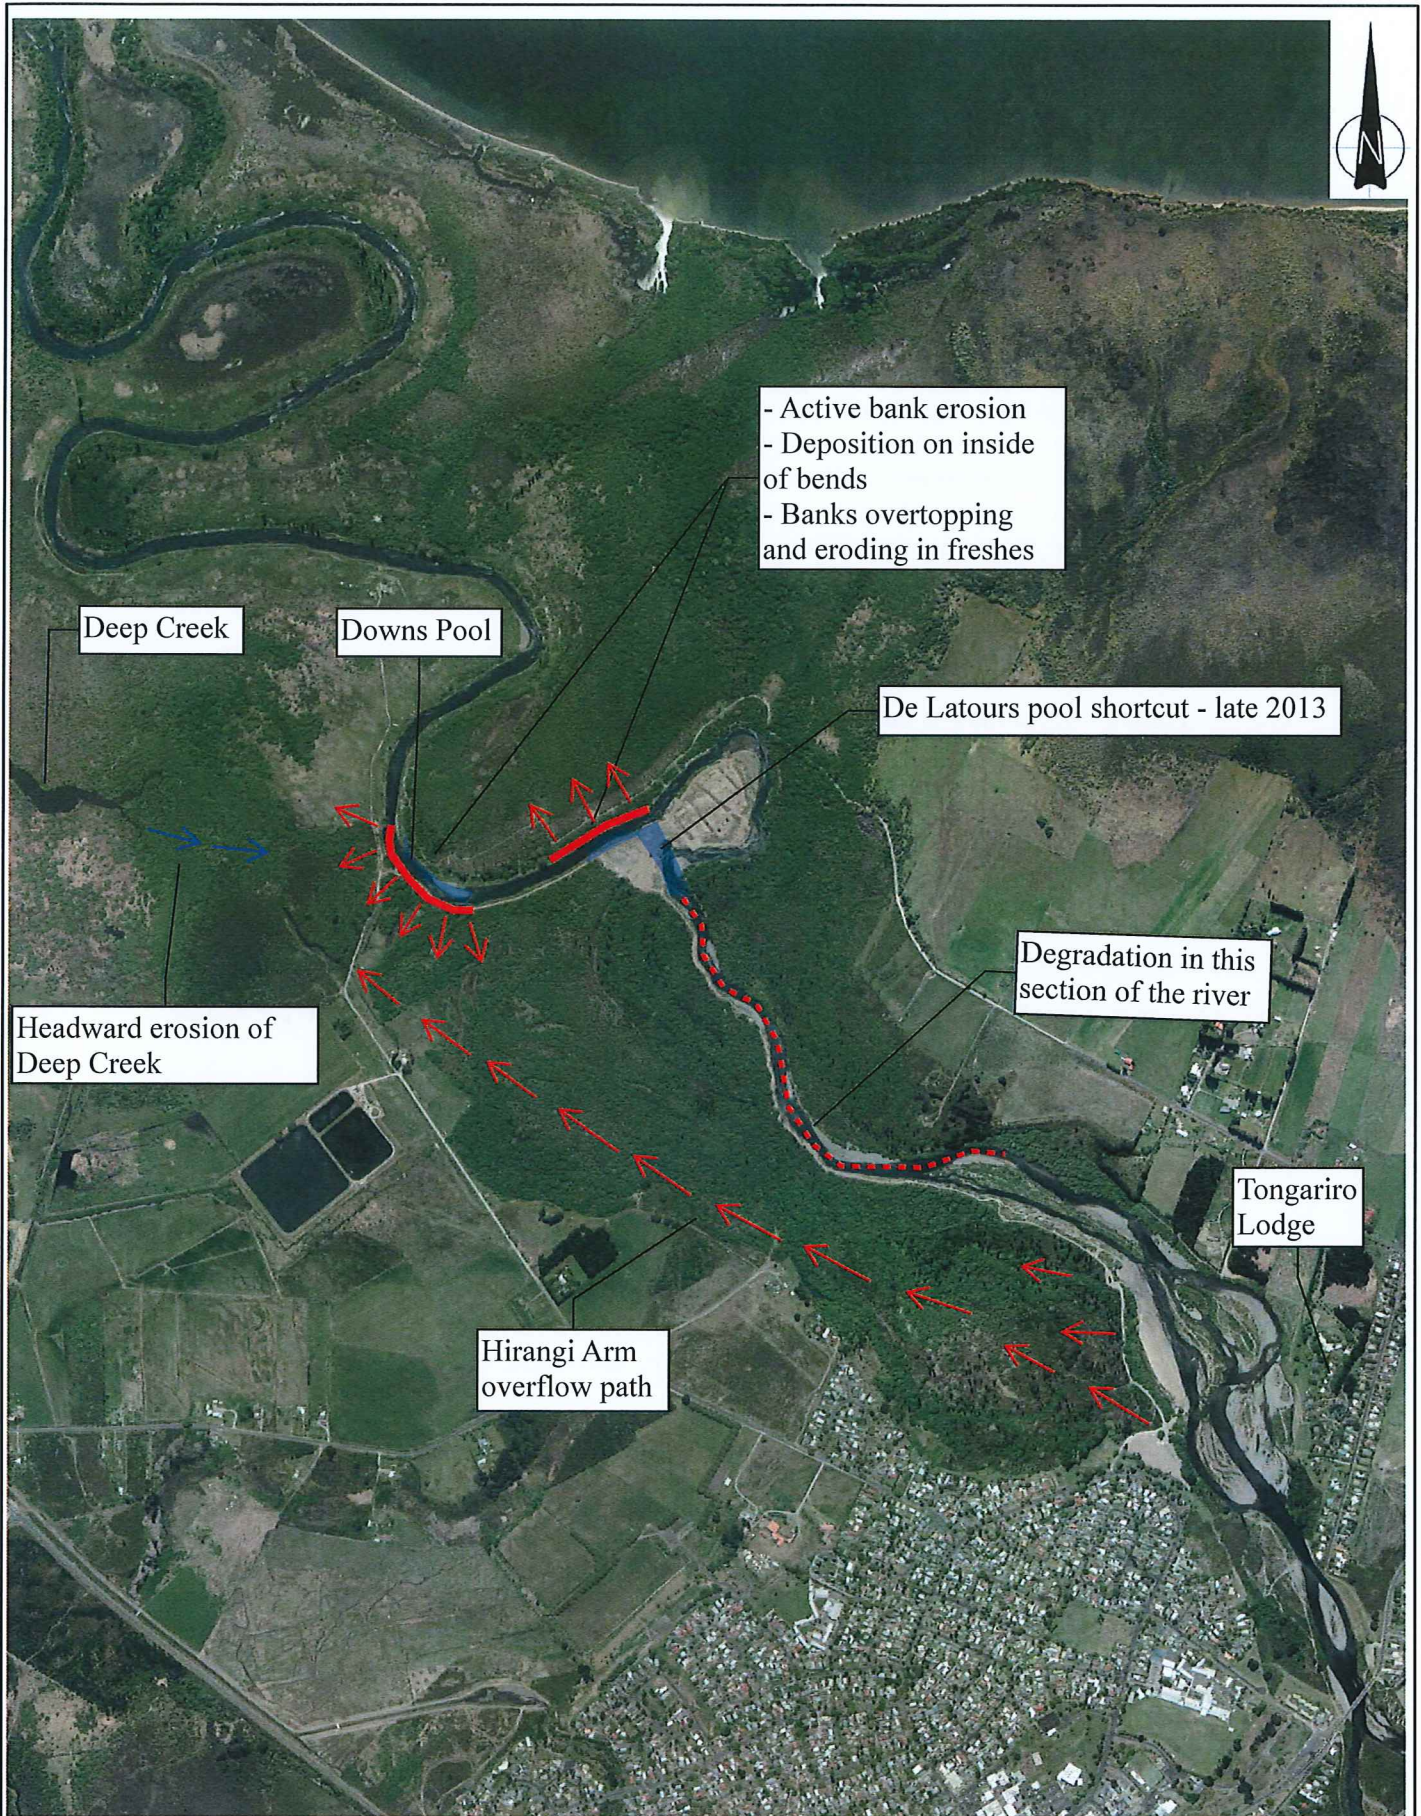
FIG. No. Figure 3-6

The layout and locations of key features of the current situation are shown in Figure 3-6 below.

- Active bank erosion
- Deposition on inside of bends
- Banks overtopping and eroding in freshes

Degradation in this section of the river

Headward erosion of Deep Creek
