Memo

Subject: Report to Advocates for the Tongariro River on 2019/20 Works

Flood Scheme Asset maintenance 2019/20

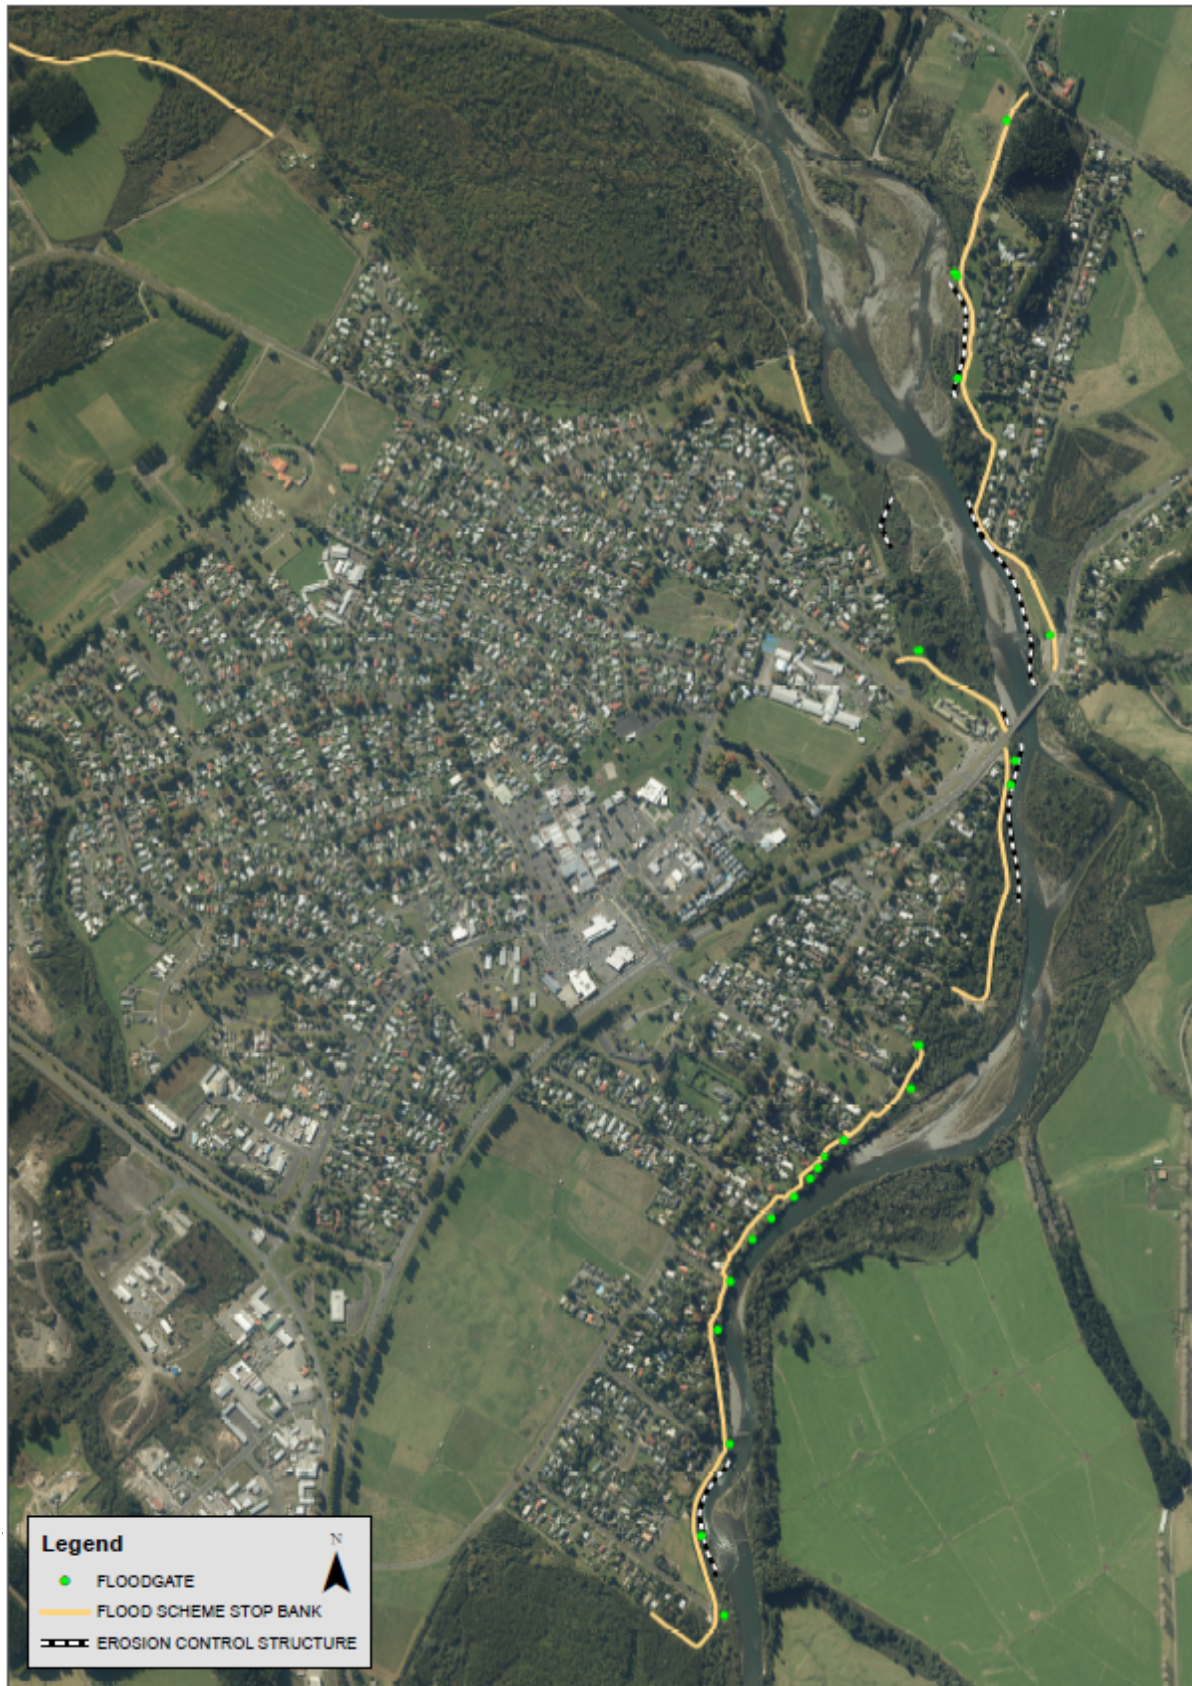
Figure 3: Tongariro Flood Scheme.

All assets including stop banks, floodwalls, flood gates, flap valves, culverts, erosion protection structures have been inspected. Most Scheme assets have been given a grade score of 2 meaning that normal yearly maintenance applies such as mowing, spraying, greasing and clearing debris for continued access etc.
